**Premarket Approval [PMA] Review
180-Day Supplement
P950037/S088**

Device Name: Reliaty External Pacemaker Pulse Generator
Model 3145 External Pacemaker Pulse Generator

PMA Holder: Biotronik, Inc.
Lead Reviewer: [REDACTED] Biomedical Engineer
Consultants: [REDACTED], EMC/EMI Review
[REDACTED], Software

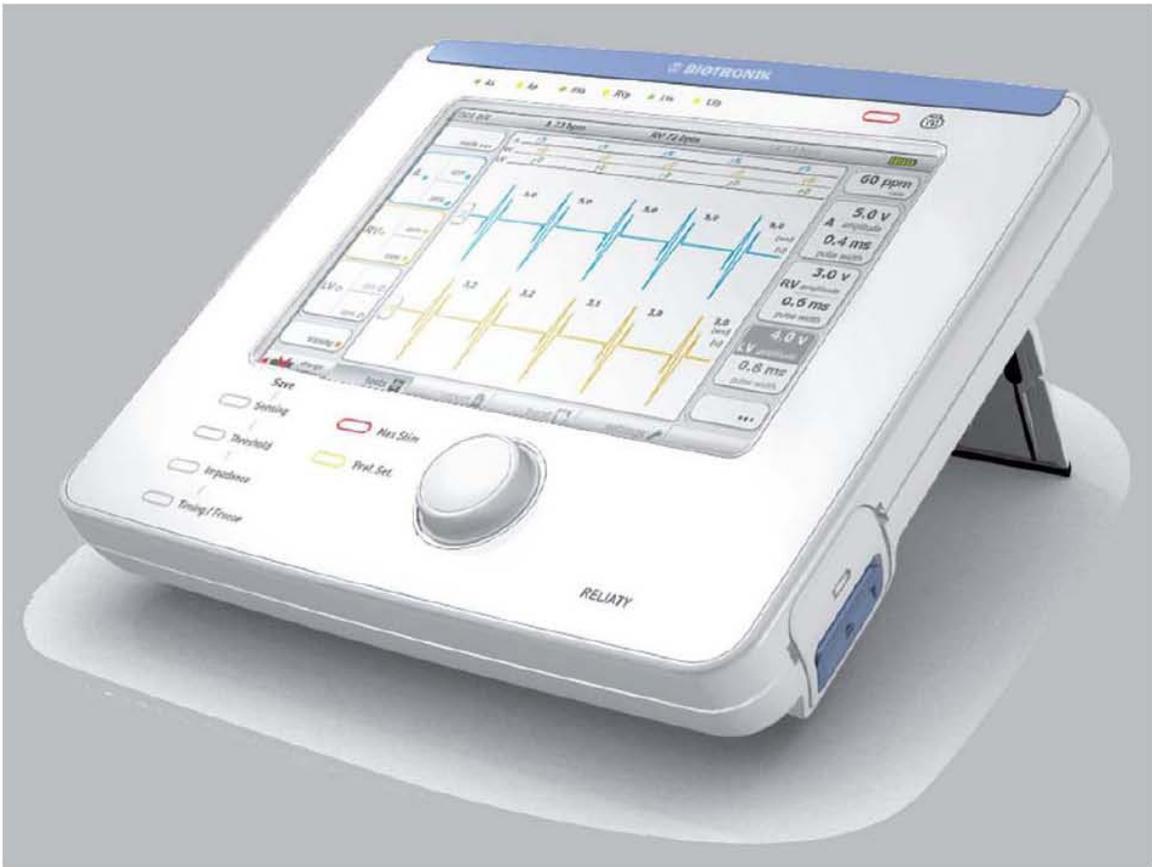
Figure 1: Reliaty Stand Alone PSA

The user interface is a touch screen in combination with a turning knob containing a mechanic-optical encoder with wheel, six LED indicators and seven buttons on the front panel. The user controls the operations of the device through its LCD touch-screen, control-knob and control buttons. The user monitors device measurements, heart activity and device status through its LCD display and LED indicators.

The fixation mechanism inside of the control knob (see Figure 1 above) has been modified for a tighter connection. The result is that the knob can be mounted more securely and remain centered while turning. It does not affect the user, device specifications, or device use. I have no questions or concerns.
