MEMORANDUM

P960013/S068/A001 Tendril Leads Helix-Shaft Subassembly modification
P950022/S079/A001 Durata Leads Helix-Shaft Subassembly modification
St. Jude Medical

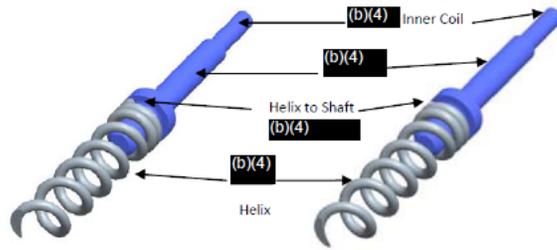
1488 Helix-Shaft Assembly

Proposed Helix-Shaft Assembly

Figure 3: 1488 Helix-Shaft Assembly and Proposed Helix-Shaft Assembly

The helix design is not new, nor is the material as it is used on the current market approved Model 1488 lead. Per the sponsor, the Tendril Model 1488 lead approved under P960013/S07 on March 7, 2000, has demonstrated a long history of proven reliability. The Model 1488 lead and the proposed helix design both incorporate a (b)(4). The product specification and welding requirements remain unchanged with the proposed helix-shaft design as demonstrated by the (b)(4) testing done in qualification testing. The shaft design is not new, nor is the material as it is used on the current market approved Model 1488 lead. As shown in Figure 3 below, (b)(4) is used in the same application in both the Model 1488 lead and the proposed assembly.

For both the Model 1488 assembly and proposed helix-shaft assembly, the connection design on the proximal end of the shaft includes an (b)(4). In addition, the connection on the distal end of the shaft includes an (b)(4). The product specification and welding requirements remain unchanged with the proposed helix-shaft design.
